*RM57Lx Microcontroller*

**Silicon Revision A**

# **Silicon Errata**

Literature Number: SPNZ214C  
May 2014—Revised May 2016

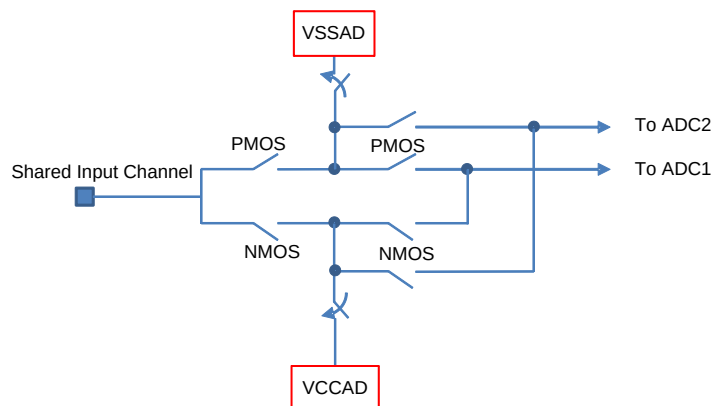
**Figure 2. Shared Input Channel in "Open" State**

**Issue**      This microcontroller (MCU) has two Analog-to-Digital Converters (ADCs). Some of the input channels are unique to ADC1 while some are shared between ADC1 and ADC2. [Figure 2](#) shows a block diagram of an input channel shared between ADC1 and ADC2.

The PMOS and NMOS switches are open indicating that this shared input channel is not currently being sampled either by ADC1 or by ADC2. Also, there are switches to VCCAD and VSSAD that are closed. If any current is injected into this analog input, any leakage through the open PMOS switch will be shunted to VSSAD. These switches to VSSAD and VCCAD are opened as soon as this shared input channel is being sampled by either ADC1 or ADC2.
