# Test Report

Report No.: SZPR101229117701E

**Client** : Samtec Electronics (HuiZhou) Limited

Sample Name : SIR1-15-L-S-A

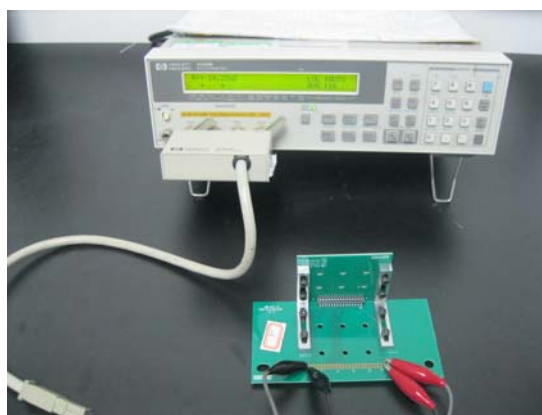
---Test Current: 10 milliamps max

---Measure and record the Low Level Contact Resistance

LLCR test

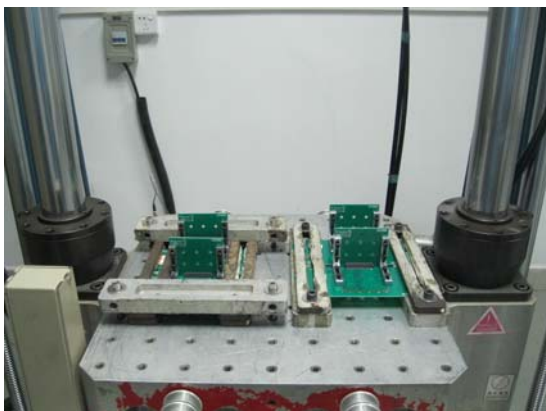
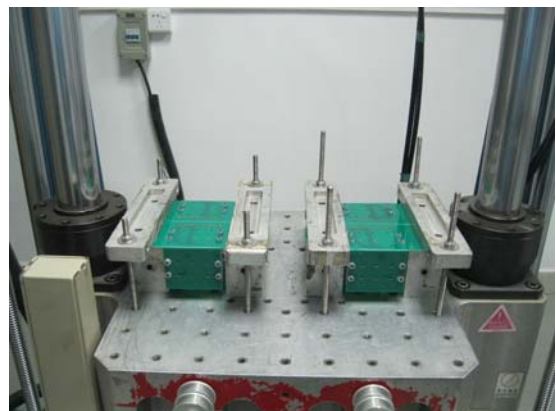
- Wave form: Half-sine
- Acceleration: 100 g<sub>n</sub>
- Pulse duration: 6 ms
- Direction: Axis  $\pm X$ ,  $\pm Y$ ,  $\pm Z$
- Number of shocks: 3 shocks /axis, 18 shocks in total

**Test Results:** There was no evidence of physical damage to the tested samples after the test.

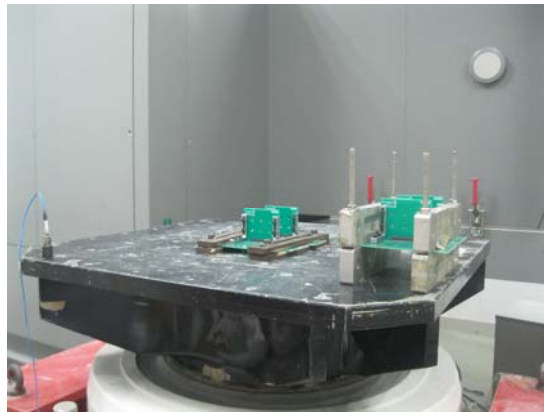
---Acceleration: 7.56 Grms

---Direction: Axis X, Y, Z

---Test duration: 2hours/axis

**Test Results:** There was no evidence of physical damage to the tested samples after the test.

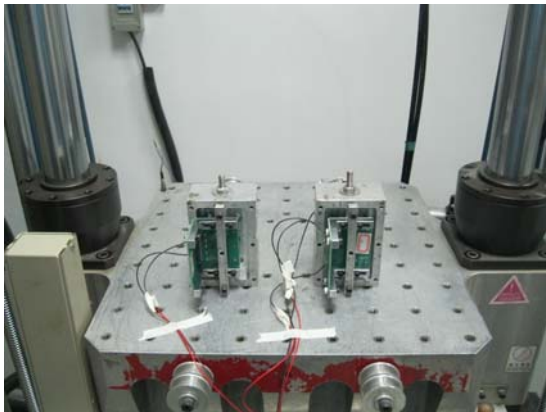
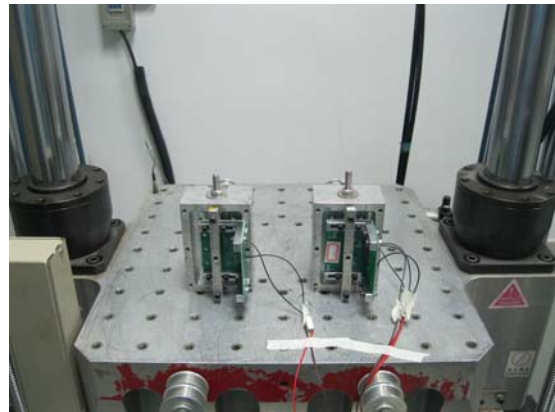
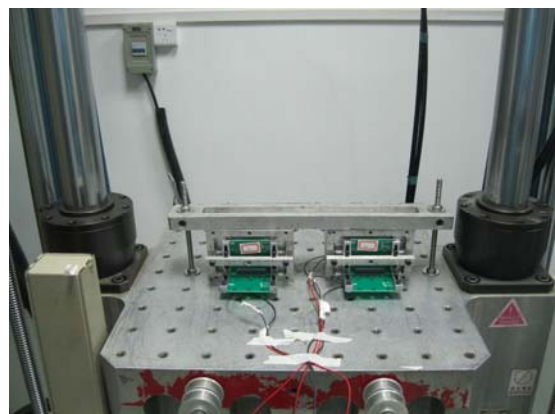
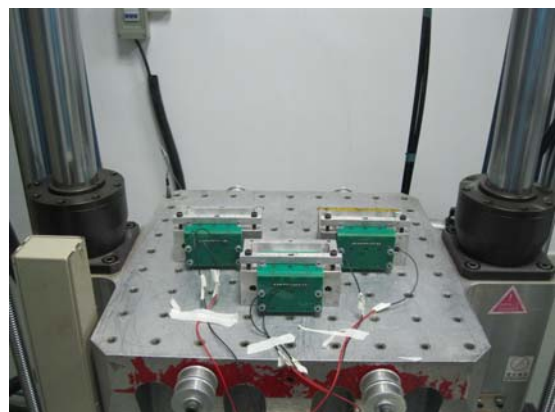
- Wave form: Half-sine
- Acceleration: 100 g<sub>n</sub>
- Pulse duration: 6 ms
- Direction: Axis ±X, ±Y, ±Z
- Number of shocks: 3 shocks /axis, 18 times in total
- Monitor the discontinuity duration of samples during the test

**Test Results:** After the test, there was no evidence of physical damage to the tested samples and the low microsecond event detected was never greater than 0.1 microsecond. Other characteristics should be evaluated by the client.

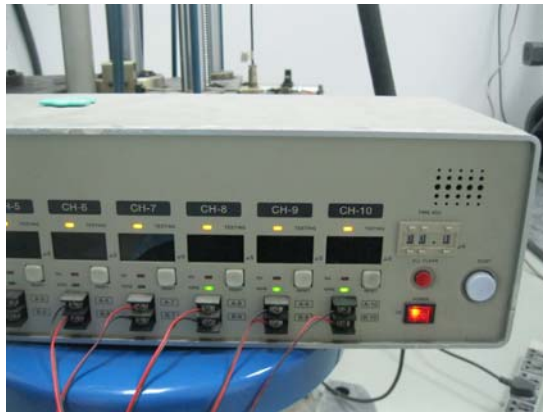
Monitor during the test

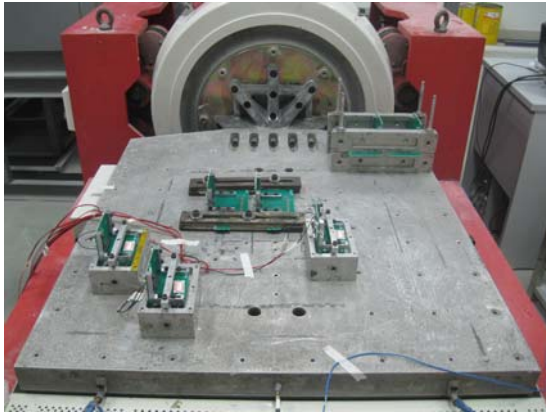
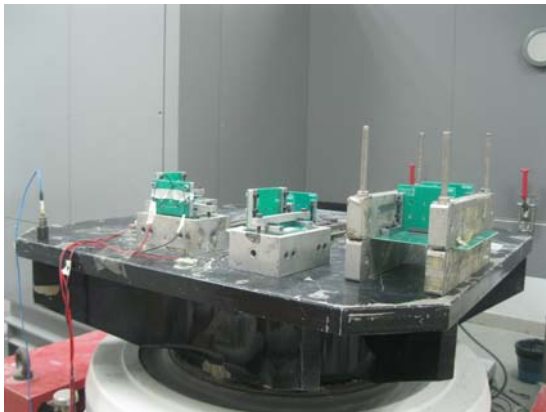
---Acceleration: 7.56Grms

---Direction: Axis X, Y, Z

**Test Results:** After the test, there was no evidence of physical damage to the tested samples and the low microsecond event detected was never greater than 1 microsecond. Other characteristics should be evaluated by the client.

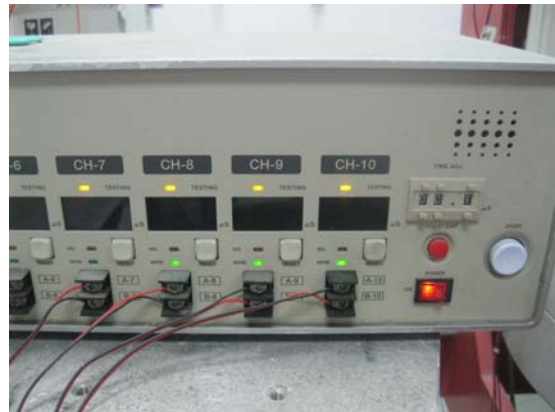
monitor during the test
